THIS DOCUMENT REPRESENTS THE TECHNICAL CHANGES TGB HAS IMPLEMENT ON THE 2006 UNITS. REFER TO THE SUMMARY PAGE FOR THE VIN #S OF WHEN THE CHANGES WERE PUT INTO PRODUCTION. ATTACHED IS 10 BULLETINS REFERRING TO AREAS OF CONCERN AND THE SPECIFIC CHANGES TGB MADE TO RECTIFY SUCH ISSUES.

2006 Warranty Claims and Improvement Table

TGB TECHNICAL BULLETIN

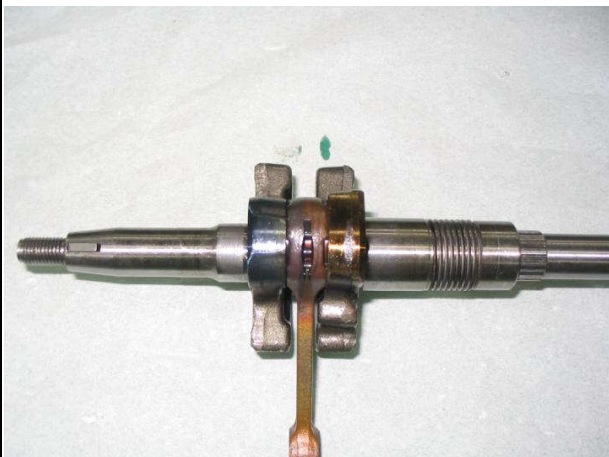
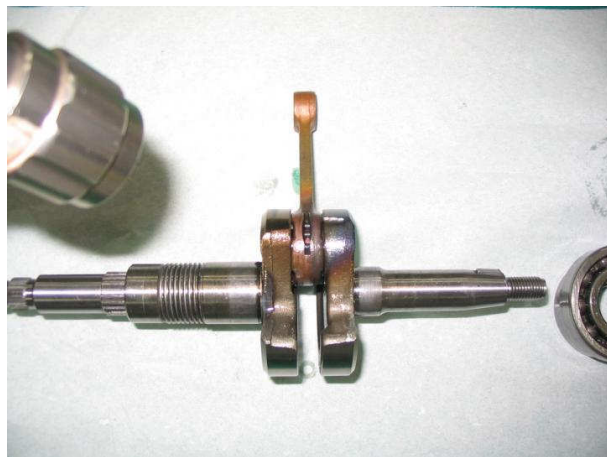
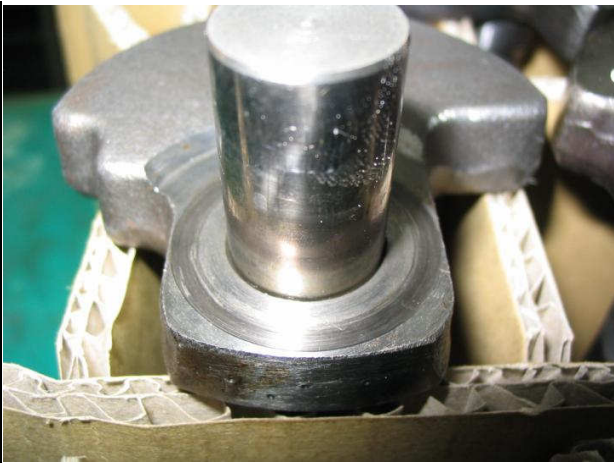
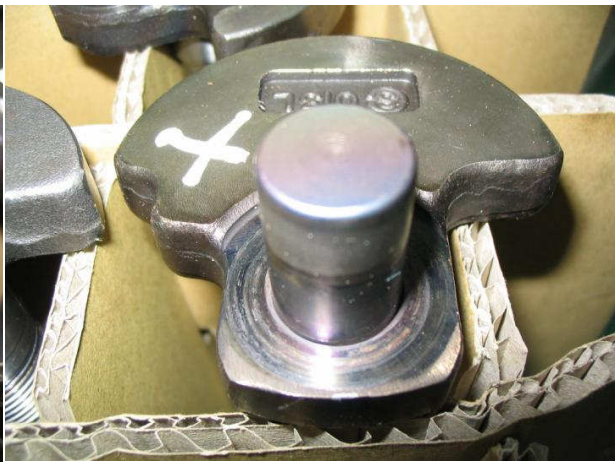
We received claims that big end bearing of con rod melted within short mileage(see picture 1, 2, 3, 4).

Picture 1 : defect crankshaft

Picture 2 : defect crankshaft

Picture 3 : defect crankshaft

Picture 4 : defect crankshaft

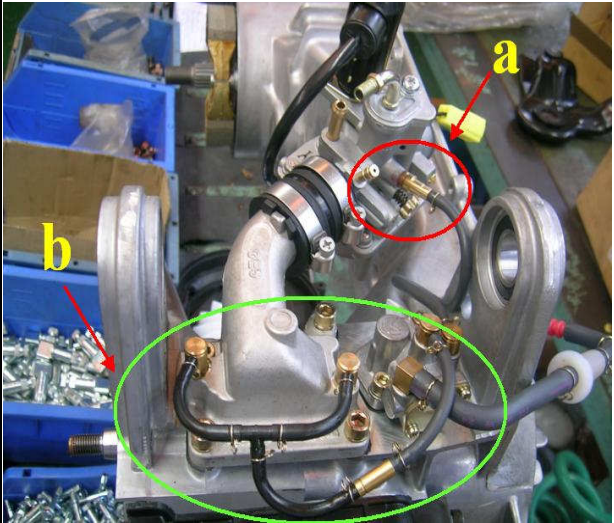
1) original oil supply system (see picture 5): oil pump pumps oil to a) carburetor and b) both L. and R. side check valves of intake pipe Assy.

Picture 5: Original oil supply system

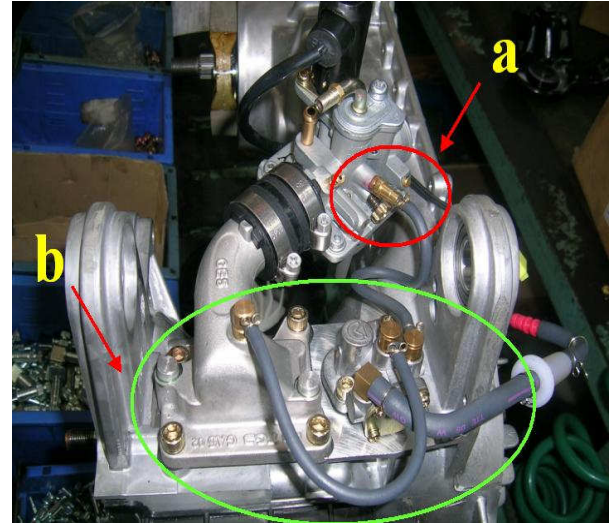
Picture 6: New oil supply system

2) new oil supply system (see picture 6): oil pump pumps oil to a) carburetor and b) check valve on intake pipe Assy.

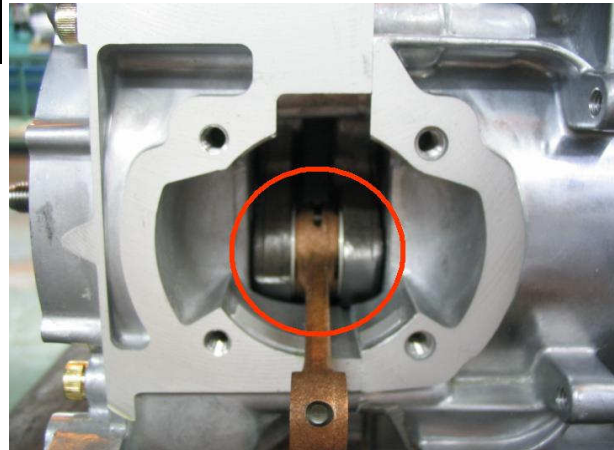
Picture 7 : new crankshaft

A) replace with new crankshaft(having washers at both side)(see Picture 7)

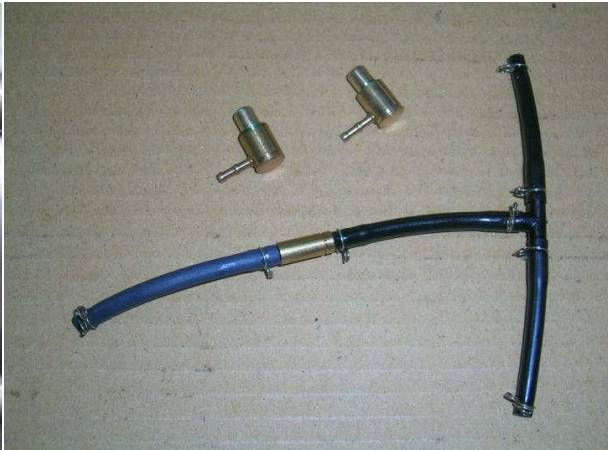
Picture 8: three way check valve assy. (part number 425038)

A) cancel three way check valve Assy.(part no. 425038, see Picture 8)

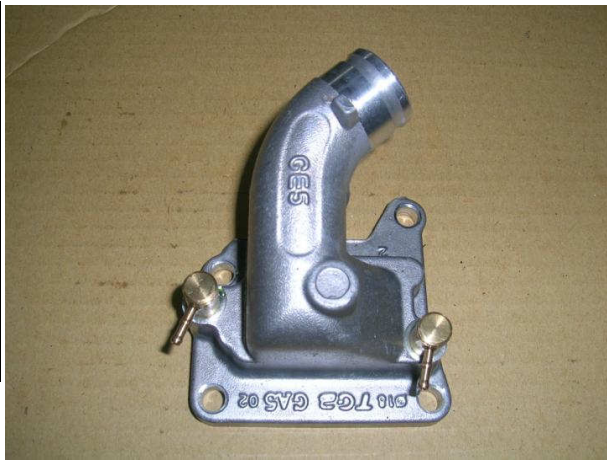
Picture 9: Original intake pipe assy.

B) replace original intake pipe Assy. (part no.421001, see Picture 9). with new intake pipe Assy. (part no.421001A, see Picture 10).

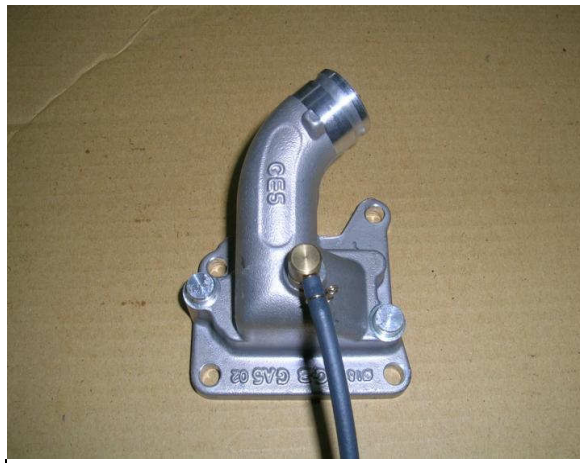
Picture 10: new intake pipe assy.(part no. 421001A) including an new oil tube (part no. GA605PP02)

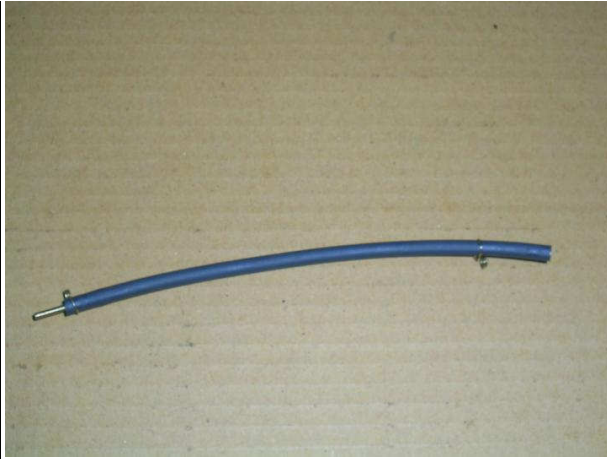
Picture 11: new oil tube (part no. GA605PP02)

C) Connect oil pump and new intake pipe Assy. with an oil tube (part no. GA605PP02, see Picture 11).

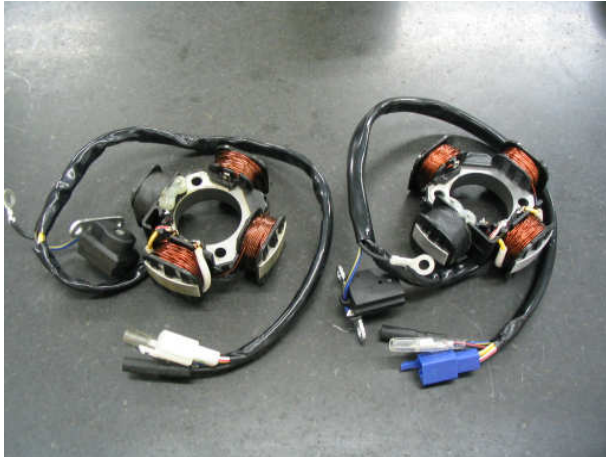
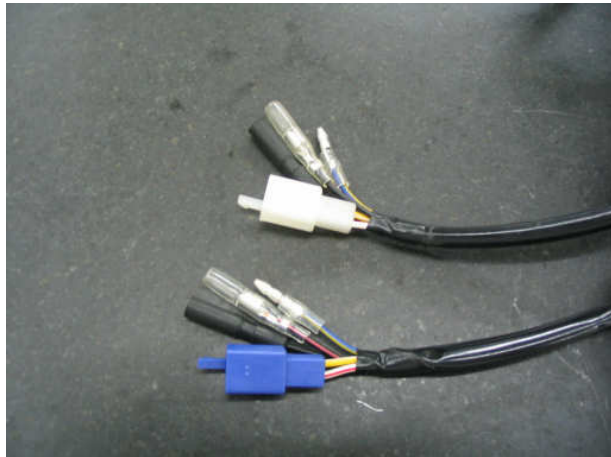
We received claims that our scooters would suddenly turn off and then could not start anymore due to stator problem.

Picture 1 : original stator (white color plug)

Picture 2 : new stator (blue color plug)

1. Change stator supplier
2. To execute full inspection
3. Modify the plug from white color to blue color

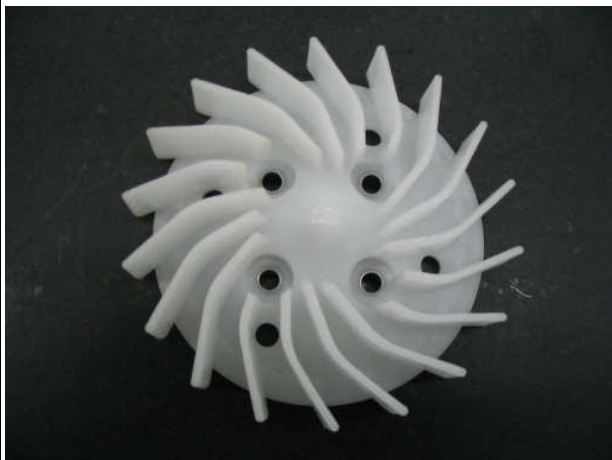
We received claims that cooling fan (part no. GA608PL10) is easy to be defect.

four-hole cooling fan (part no. GA608PL10)

1. Use 100% PP material
2. Modify two-hole type to four-hole type

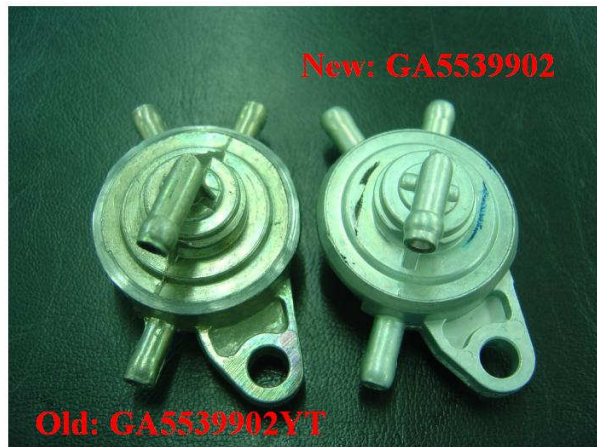
To extinguish the possibility of engine stop due to fuel cock problem .

LH is original, RH is new

Change fuel cock supplier

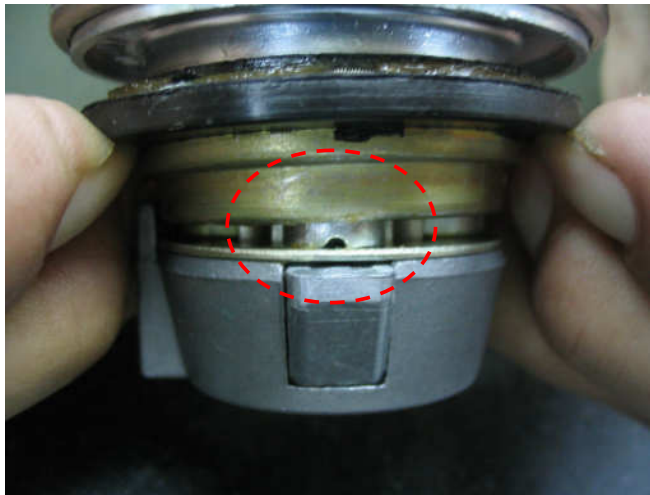
Engine stops due to fuel tank cap problem

Modify the fuel tank cap with a hole.

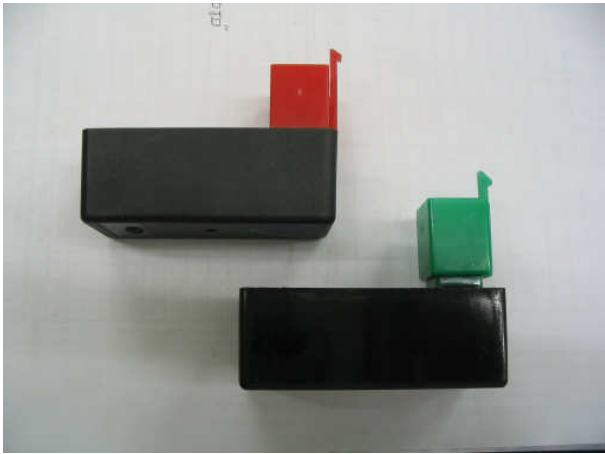
To extinguish the possibility of stop engine due to C.D.I. problem .

New C.D.I. Is red color

Redesign C.D.I.

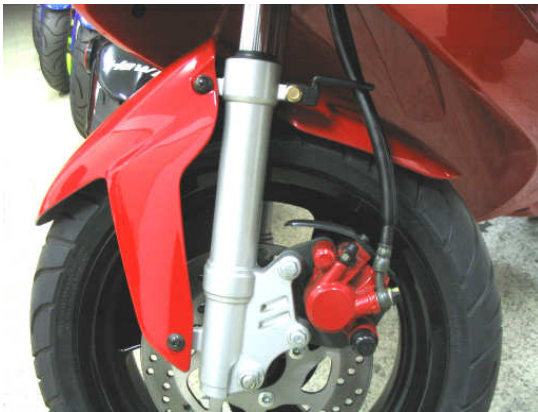
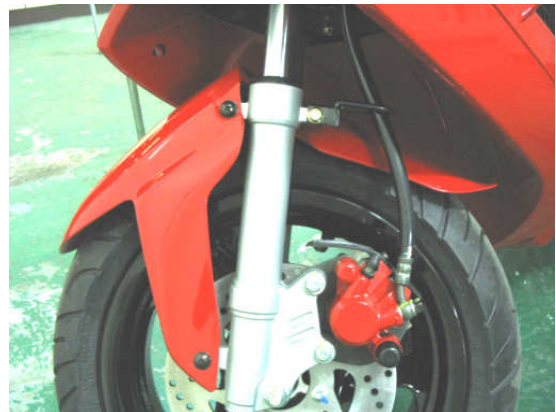
before Modified

fog(water) inside headlight

Introduction:**1. Modify the front fender.**

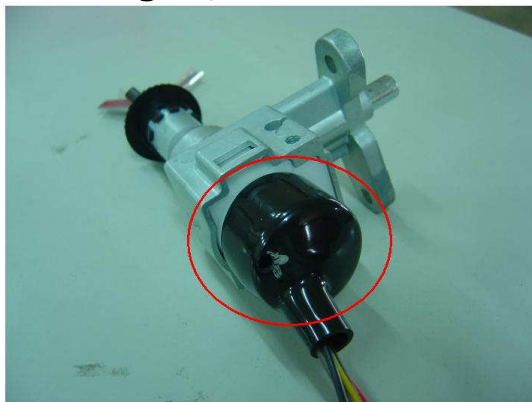
isolation glue, tin terminals and rubber cover

**2. Modify main switch assy.**

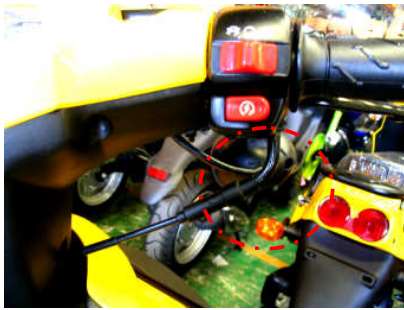
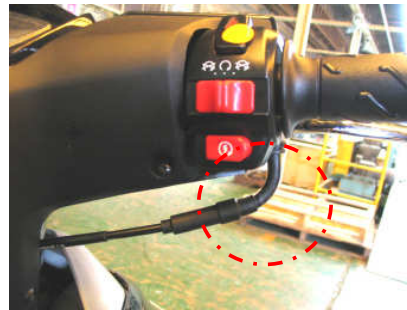
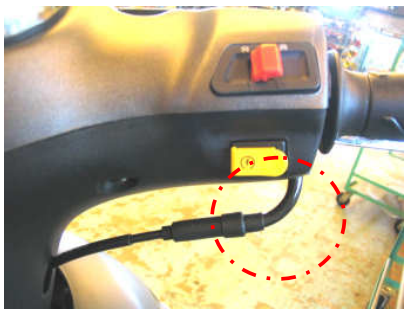
throttle cable can not work smoothly

Introduction:**1. Modify the angle of throttle cable shape.**

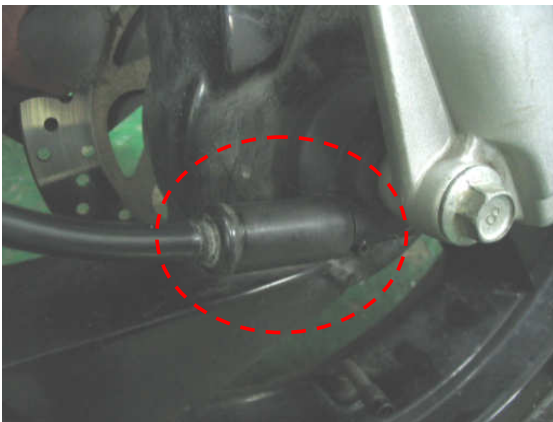
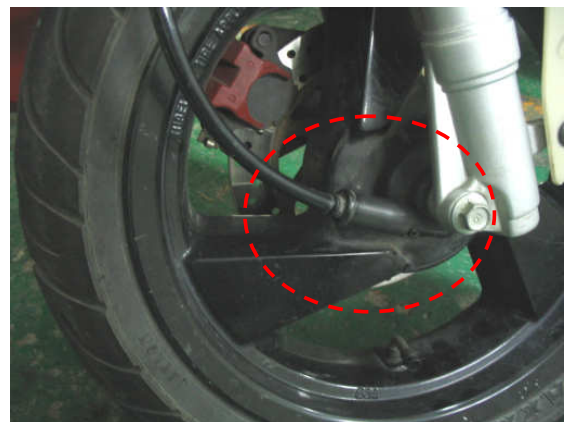
speedometer cable part no. 411630

speedometer gear and cable damaged by salt or dirt.

Install extra rubber cover on the speedometer cable to protect from salt and dirt.

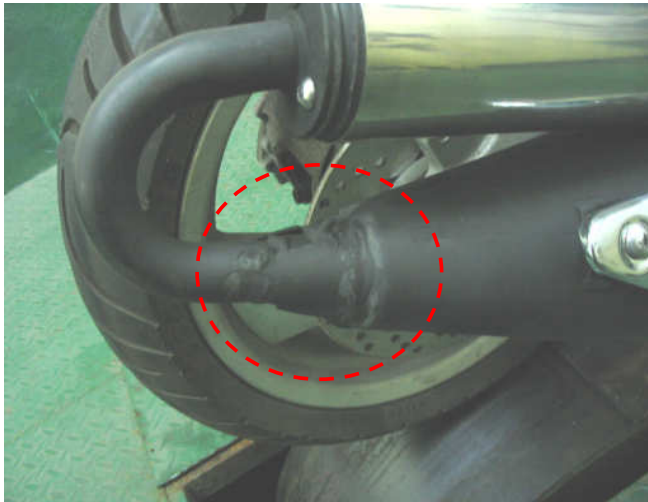
tail pipe crack (broken)

Introduction:**1. Enhance the welding to strength of tail .**
